# Product Advisory

VMT PC software to versions 2.2.1 to 2.2.3

## Advisory Summary

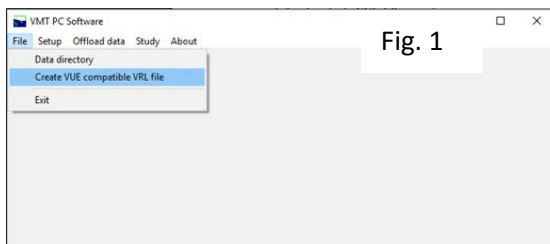
Vemco has identified a bug in the VMT PC software (versions 2.2.1 to 2.2.3) which causes the 9000 series sensor code spaces (i.e. A69-9002, A69-9004 and A69-9006) to be incorrectly translated during the VRL file creation.

Open VMT PC software (version 2.2.4) and select Create VUE compatible VRL file (Fig. 1). Select the VMT flash file. The VRL file will be created in the data directory which you have selected the flash file from (VMT PC software displays the directory the VRL file is created in-highlighted in Fig. 2 below).
