Product Advisory

VR2AR receiver

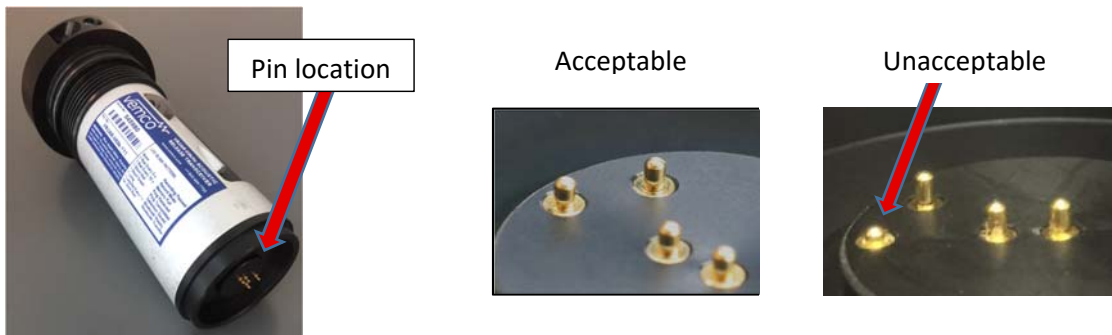
We have been recently made aware of a manufacturing issue causing the electrical compression pins to become seized in the VR2AR receiver. Seizing of these pins can affect the receiver's acoustic release function. While the VR2AR receiver includes redundant electrical compression pins, we are none the less advising customers to always test the release function on each VR2AR prior to every deployment.

- 1) Open receiver in a controlled, indoor environment and inspect pins (see picture below).
- 2) With clean hands, use your finger to press pins in lightly to ensure pins are compressing and fully releasing (see picture below).
- 3) When you have closed the unit for the final time before deployment (i.e. to connect or replace battery), perform a test release of the lug using VUE or your VR100-200 receiver for confirmation of proper connection.
- 4) It is important to perform the lug release test prior to any deployment.
- 5) If you need to re-open the receiver, complete the release test again.
- 6) If the pins do not compress and release fully (step 2 above) and/or the receiver does not release the lug (step 3), please contact the Vemco support team
